DEPARTMENT OF TRANSPORTATION

Quality Assurance and Source Inspection

OBG Segment 13AE / Bay 14

WELDING INSPECTION REPORT

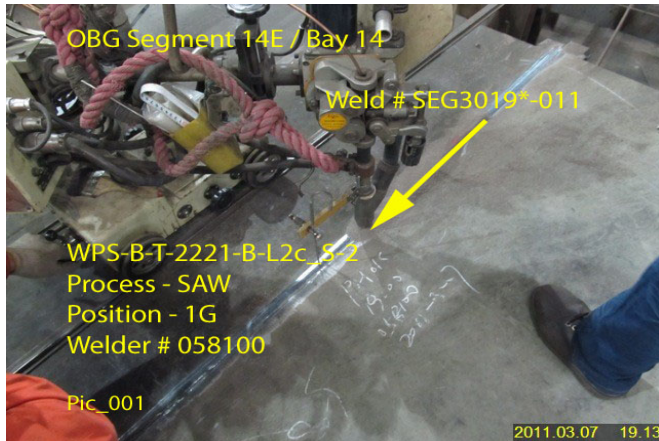
Sub Arc Welding (SAW) in the 1G position of Deck Panel DP3165 to DP3166 weld # SEG3019*-011. The welder is identified as 058100. Quality Control (QC) is identified as Zhong Guo Hai. The welding variables recorded by QC appeared to comply with WPS-B-T-2221-B-L2c_S-2. See attached photograph Pic_001.

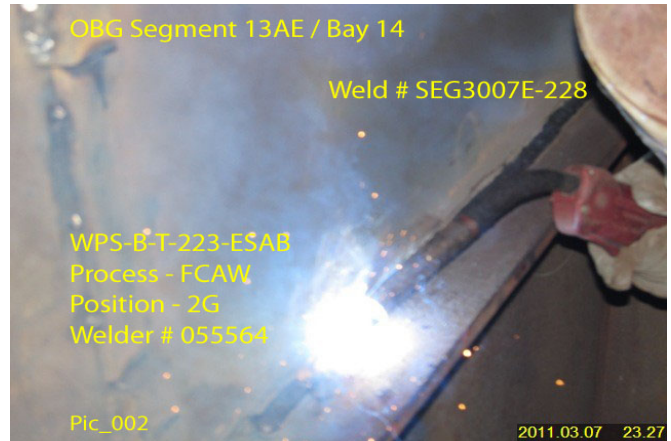
Flux Core Arc Welding (FCAW) in the 2G position of weld # SEG3007E-228. The welder is identified as 055564. ZPMC Quality Control (QC) is identified as Zhong Yang Gang. The welding variables recorded by QC appeared to comply with WPS-B-T-2232-ESAB. See attached photograph Pic_002.
